Evjeni MATO (THOMAGJINI)

## CHRONICLE OF RESTORATION INTERVENTIONS IN BUTRINT NATIONAL PARK FOR EXAMPLE THE RESTORATION OF THE CIRCUIT WALL ALONG VIVARI CHANNEL AND BUTRINT'S LAKE

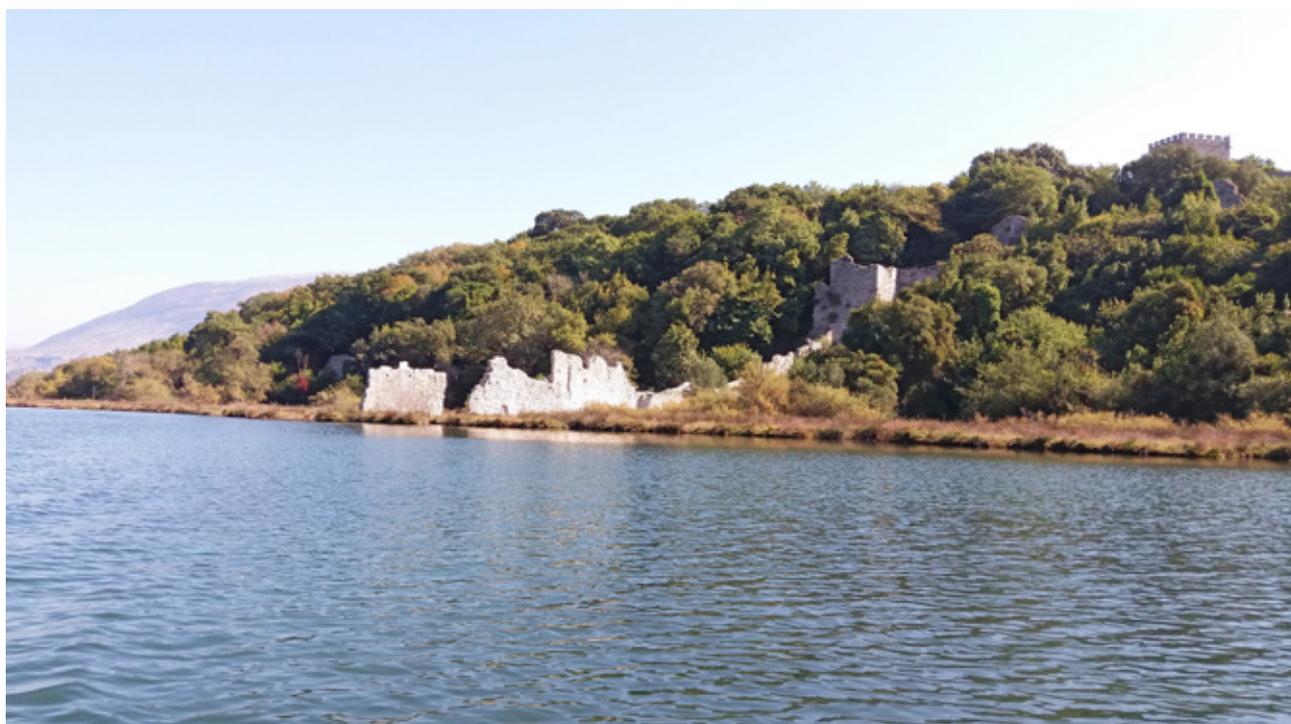
*Fragment of the circuit wall (Northwest Spur) along Butrint's Lake after restoration*

Another issue caused by the presence of the massive vegetation roots was noticed on north-west spur. After the removal of tree trunks, thick layers of organic remains were left behind which caused deterioration of the original structure, also shunt of verticality with high risk of collapsing some parts. By mechanically removing the degraded material, a huge layer of mud going up to the rock bed of wall line in a length of 3 m high it was noticed. In this layer neither organic remains nor traces of original mortar were noticed, this gave the impression that this layer of mud was used as aggregate for the connection of the inner structure of the wall. Meanwhile traces of mortar were noticed only in the outer side of wall surface (Fig. 9). In this case work consisted in the continuation of consolidation without the removal of all aggregate layer (the case of red mud), by adding the stones found in-situ and filling of the outer line with lime mortar. Considering the construction technique, this wall fragment was constructed in a hurry at a later phase as a support for the rest of the wall.

was in need of not only consolidation of the wall but also of creating supporting structures and refilling a platform to stabilize the foundations and to avoid the penetration of water inside the structure.

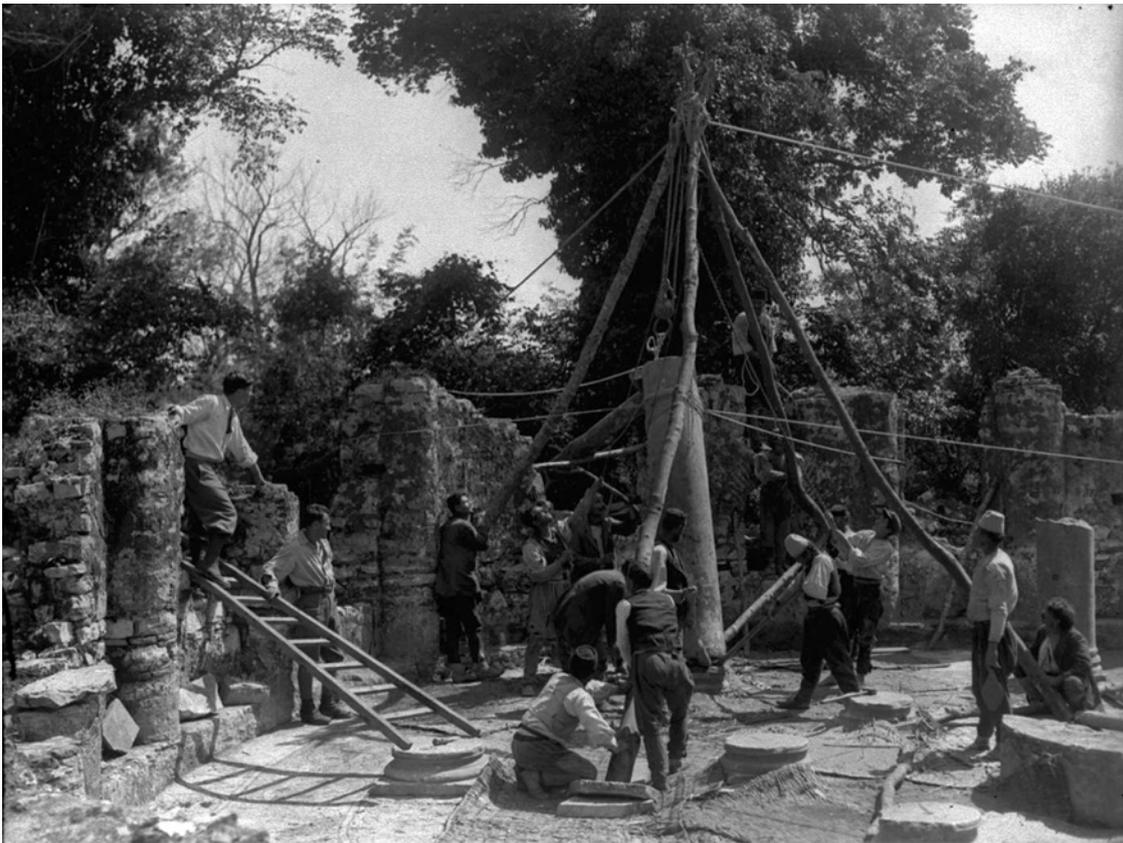
*Fig. 1. Restoration work in the Baptistery of Butrint lead by the Italian Archaeological Mission, during '30*

Despite difficulties the mission achieved both great restoration work on most of the monuments uncovered during excavations, as well as landscape improvement: cleaning up, consolidations, reinforcement of walls at risk of collapse, opening of new paths, construction of a small pier etc. The Baptistery's mosaic saw the first restoration work during 1930. The entire surface of the mosaic was established and some of the missing tessera were added<sup>1</sup> (Fig. 1).

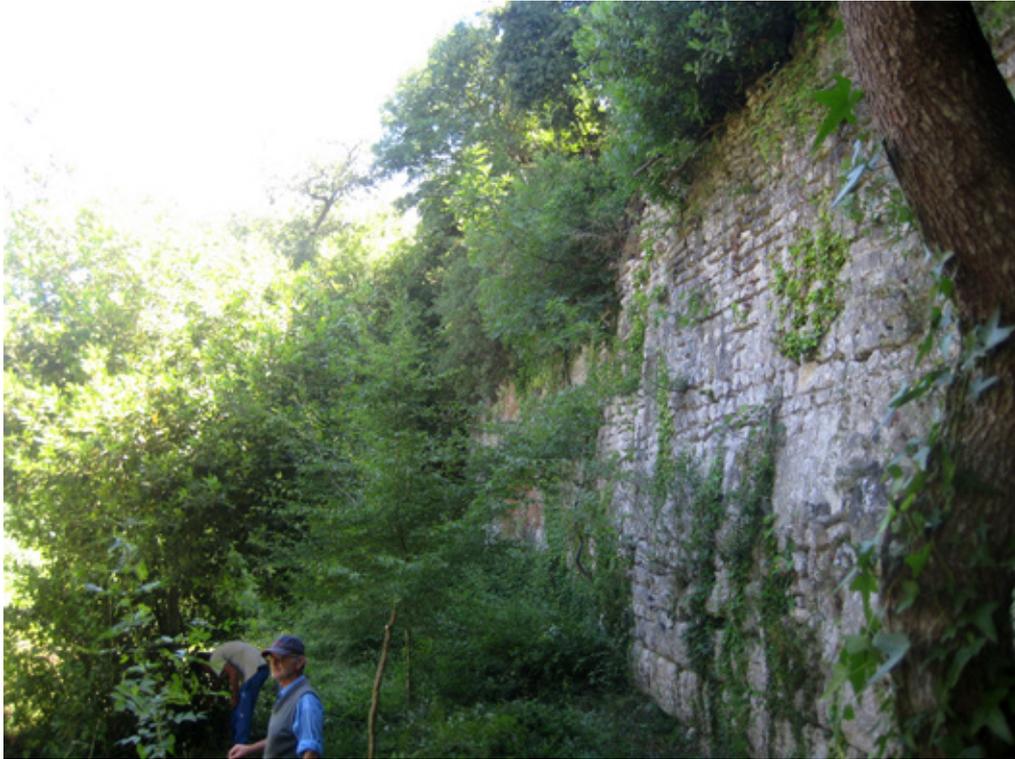
*Fig. 2. Presence of vegetation near and on the wall's structures*

The problem of uncontrolled growth of vegetation is present almost on all the monuments. Its decaying effect is greater on the monuments' structures built with mortar, in which the roots penetrate more easily (Fig. 2). This risk is also present on dry stone especially in cases where trees have grown above and place horizontal pressure by dislodging the upper part of the wall's structure. In this case the consolidating works are simple, and can be done by light technological intervention, such as mechanically cutting of the trees, or injecting chemicals into them, the clearing of vegetation up to a distance of 3-4 m around the monument, and filling the parts cleared of vegetation.

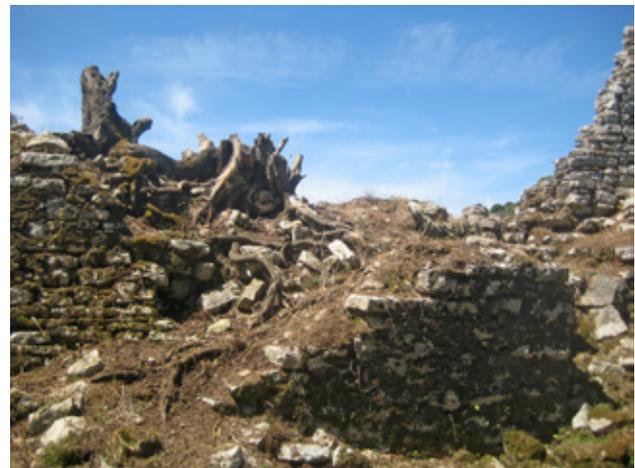
The situation is more complicated in cases where massive trunks have penetrated the monuments, weakening their structure, causing fracture and disintegration leading to complete collapse. The situation is also complicated in cases where decayed roots create cavities in which the water enters more easily

*Fig. 3. The roots and a massive trunk inserted in the structure of a medieval wall*

and as a result leads to structural collapse (Fig. 3). This situation requires better evaluation in order to understand damage to the site by tree roots<sup>8</sup>.

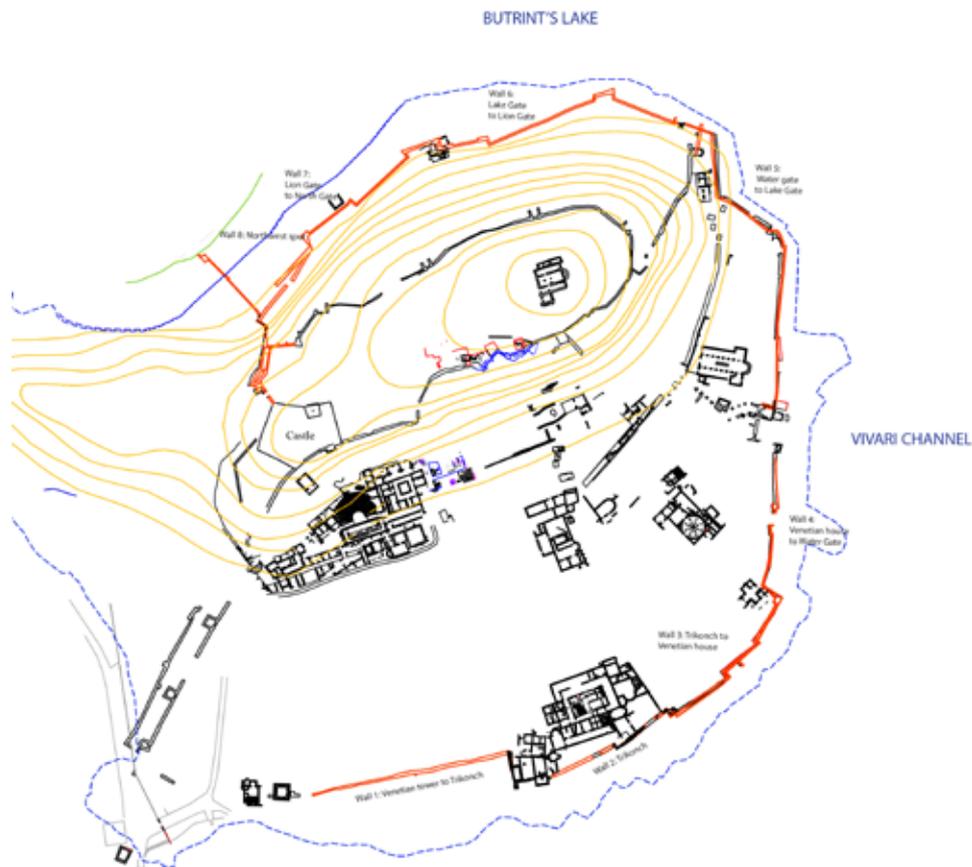
Fig. 4. Location of the restored circuit wall along the Vivari channel and Butrint's Lake

One of the specific cases of realization of restorative work throughout the years in Butrint was the restoration of the circuit wall along the Vivari Channel and Lake Butrint (Fig. 4).

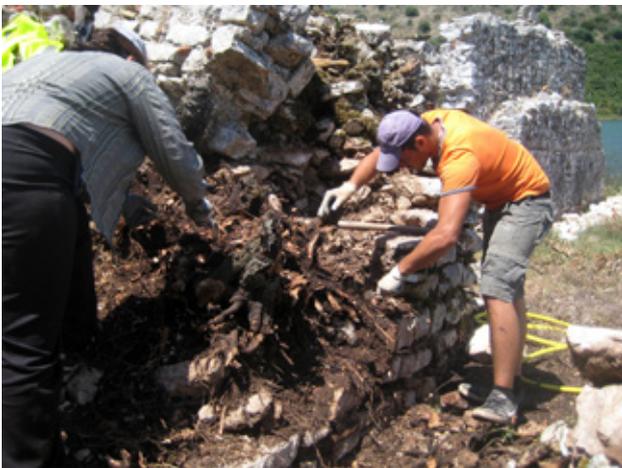
Fig. 5. Mechanical cleaning of deteriorated roots of the trees and other organic remains

Before every intervention, the work consisted of full documentation of different fragments of the circuit wall line. Continuing with the complete removal of the vegetation and creating a buffer zone of 2 m around the wall, cleaning up of the rotted roots and other organic remains, taking care of saving the dislodged stones of the structures (Fig. 5).

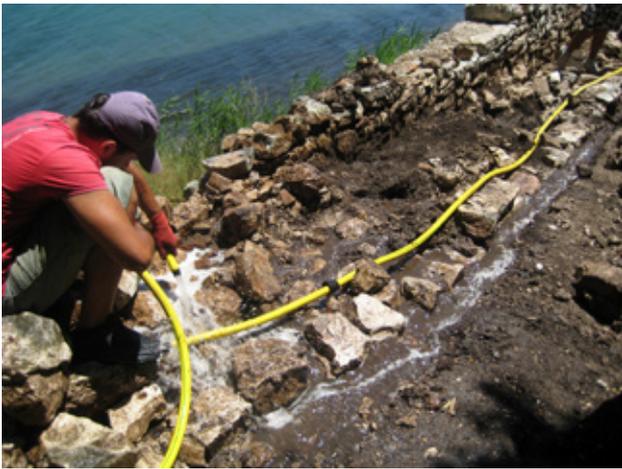
Fig. 6. Cleaning the organic remains and mud left in the inner part of wall line, with flowing water

To prevent further infiltration of the roots of the trees inside the structures (which in the past has been the main cause of wall lines destruction) they were gradually desiccated by injecting herbicide into the tree's trunk based on **Glyphosate 36%**, mixing it with water to a ratio of 1:1, while local bushes and grass were treated with herbicide to a ratio of 1:3. This was only used in those cases where the mechanical clean up (cutting and uprooting) was likely to destroy the structures.

After the mechanical cleaning of the inner part of the structure, rinsing it with clean water to remove all the organic remains, the next step was to consolidate all the movable stones and the delicate lines of the structure with lime mortar (Fig. 6).

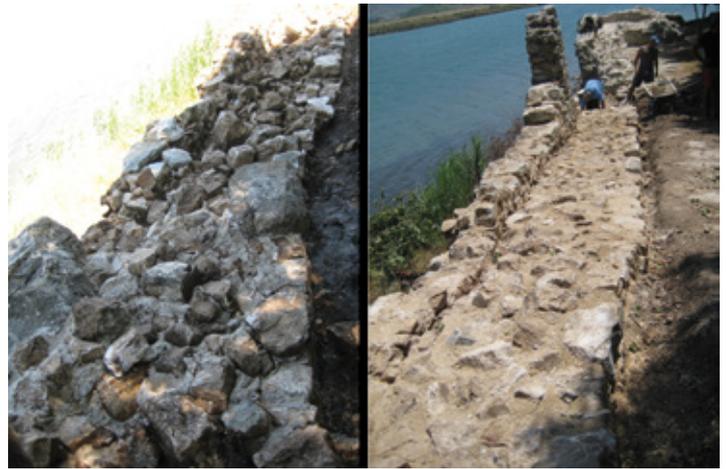
Fig. 7. Fragment from the Circuit wall line; after its cleaning from the organic remains and vegetation and after its restoration and consolidation

The wall sections that needed drastic conservation were documented, the stone's position was registered, they were carefully dismantled, and were reconstructed based on prior documentation (Fig. 7).

The consolidation of the wall's surface in general was very limited and the filling was made several centimetres inside to distinguish the new intervention from the original part.

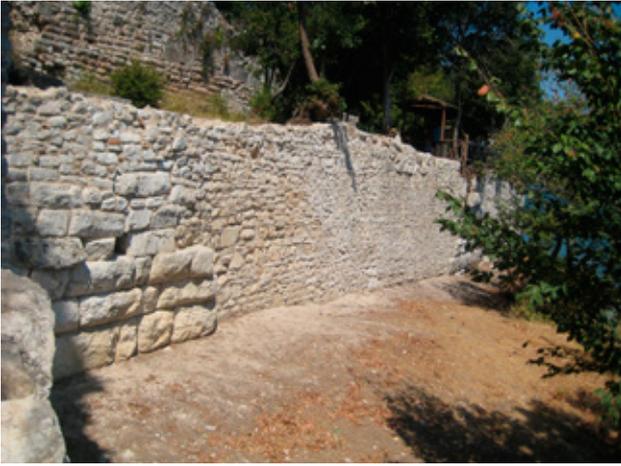
*Fig. 8. Fragment of the circuit wall line form Lake Gate to Lion Gate after restoration*

niques are obvious. Among them was the section 5a-5r on the circuit wall, close to the Lake Gate which included sections of the original Hellenistic wall and fine medieval infill masonry using Hellenistic spolia<sup>11</sup>. After removing all the vegetation, degraded tree trunks and organic remains, all the movable material was registered. The second phase was injecting lime mortar in the medieval part and in the inner part of the structures. Where fractures were visible liquid mortar was injected (Fig. 8).

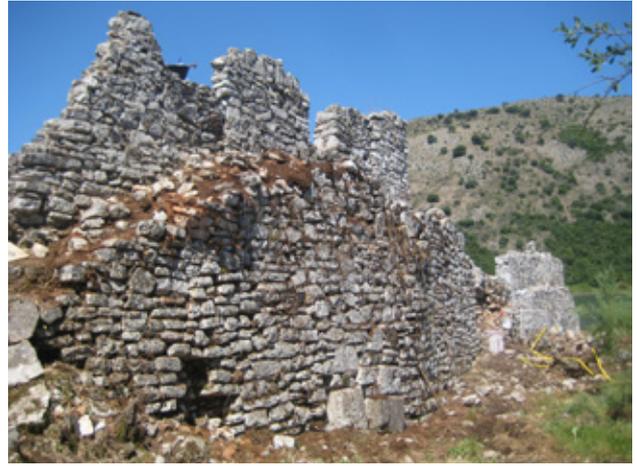
This wall line is located very close to Butrint Lake. The presence of water has covered the bases causing this degradation of terminal parts of the structures. It

*Fig. 9. Documentation of the construction technique on the northwest spur and the presence of mud in the inner part of the structure*
