## RESTORATION AND DISPLAY OF THE MOSAIC FROM THE OLD EPISCOPAL BASILICA IN STOBI

**Abstract:** *The paper focuses on the project for conservation and restoration of the mosaic from the Old Episcopal basilica in Stobi, which had been removed from its original position in 1991. The aim of the project was to relay the mosaic in situ in a way that will provide the best conditions for its further protection and maintenance.*

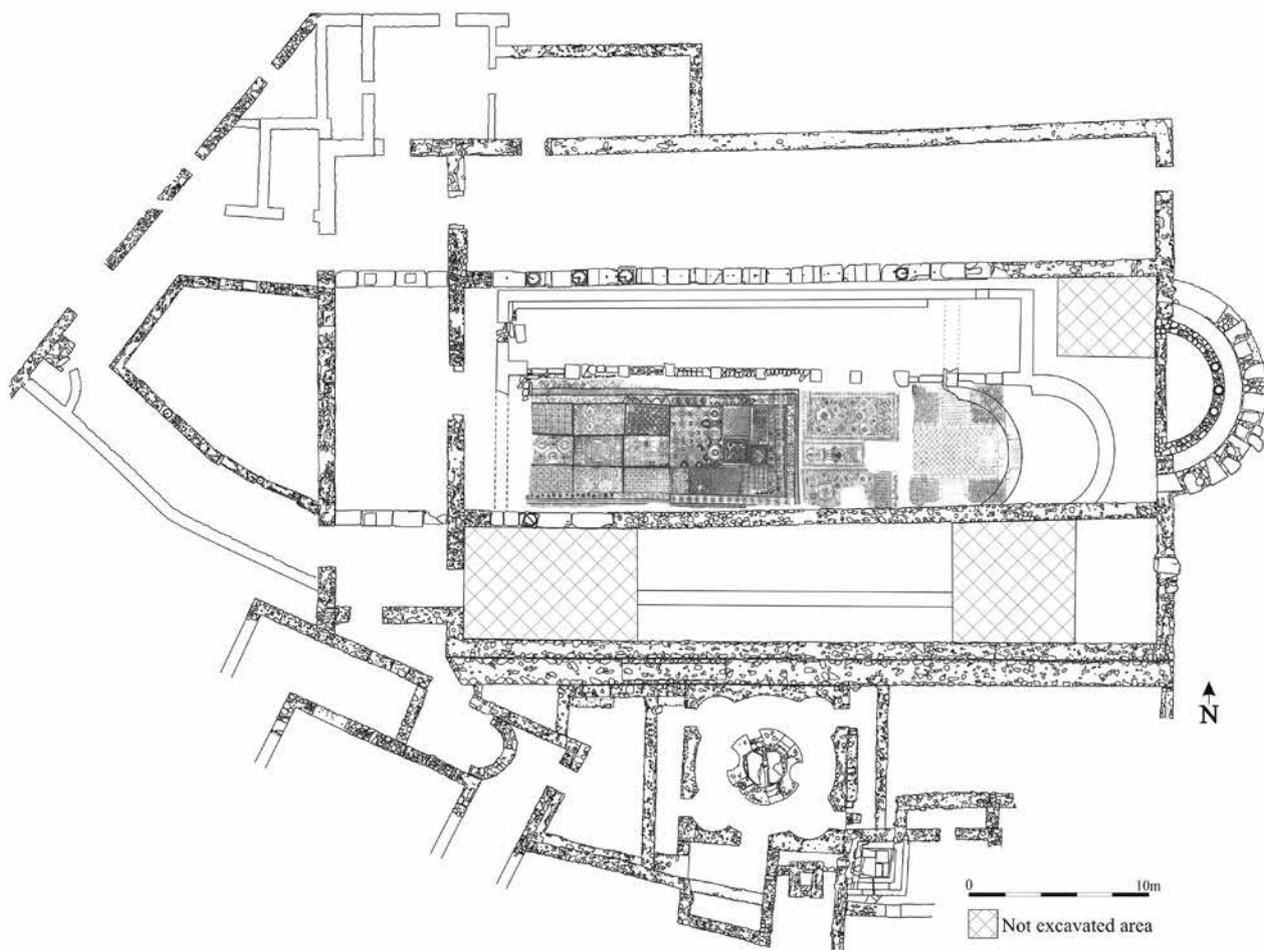
Fig.1 Ground plan showing two basilicas at different levels  
 (Drawing by: F. Hemans, T. Mitrova, interventions - M. Tutkovski)

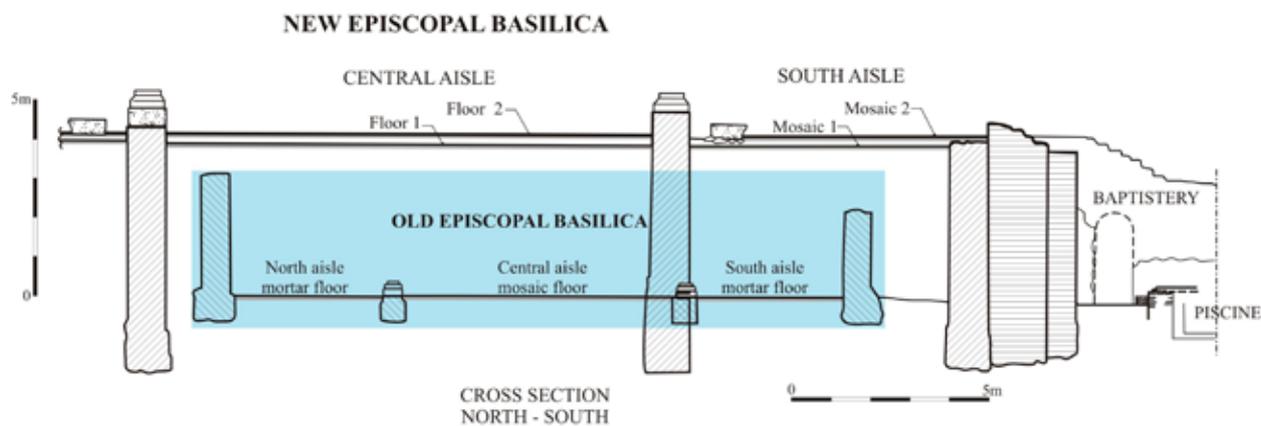
Fig.2 Cross section of the Episcopal basilicas  
 (Drawing by: F. Hemans, T. Mitrova, interventions - M. Tutkovski)

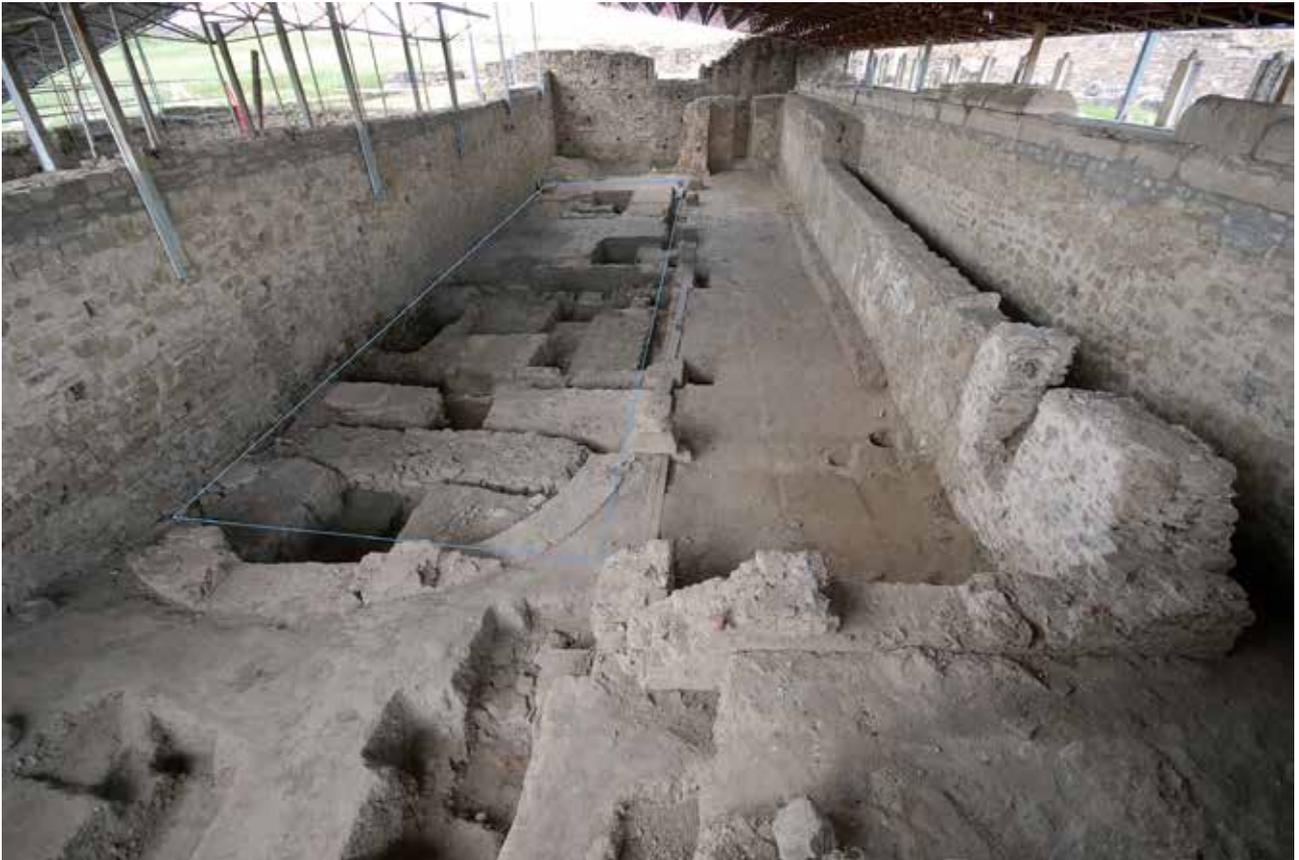
Fig.3 Old episcopal basilica before archaeological excavations in 2012. Blue line is showing the original location of the mosaic floor (photo: M. Tutkovski)

and in 2012 archaeological excavations began in the area below the mosaic level in the nave of the church (Fig.3). The main objective was to gain understanding of the elements needed to create a strategy for re-laying and final presentation of the mosaic.

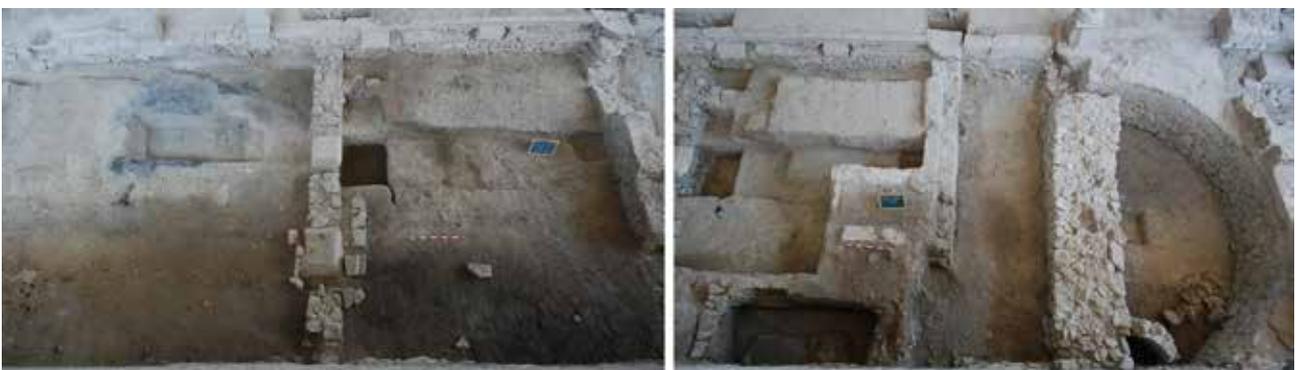
Over the course of the excavations it was established that the northern half of the nave is constantly exposed to sources of moisture, detected through all the layers from the most upper down to the bedrock (Fig.4);

Fig.4 Situations during the archaeological excavations – views from south (photo: M. Tutkovski)

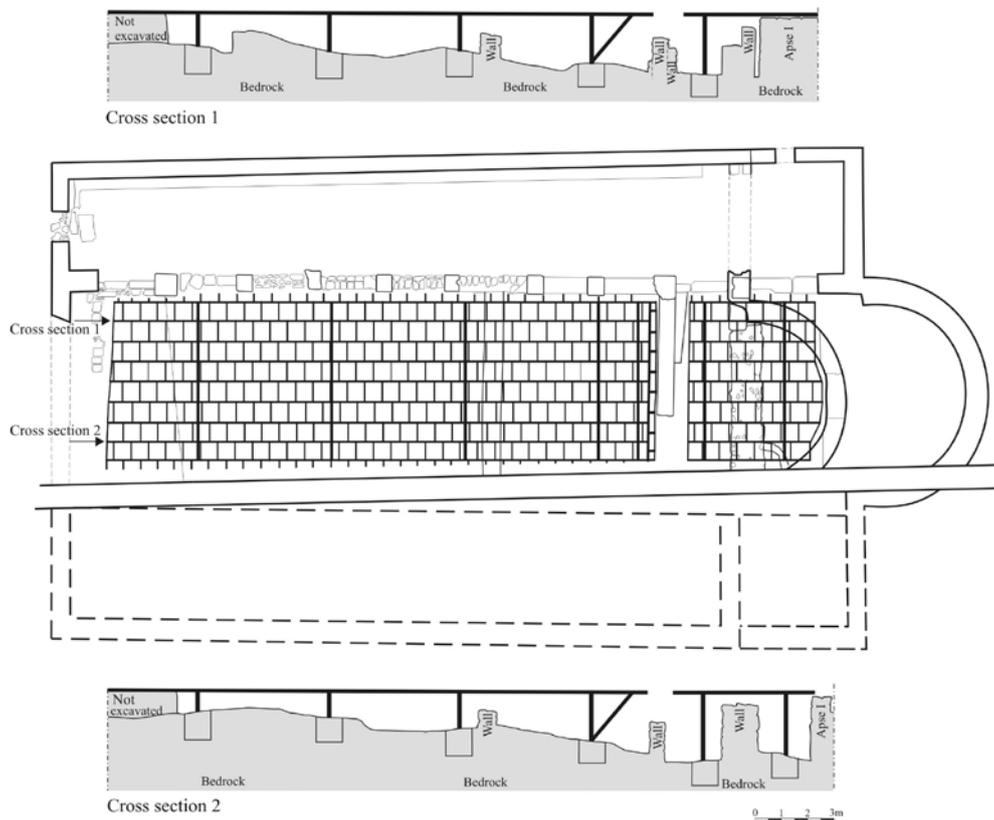
On the other hand, the freestanding platform would be positioned over piers dug into bedrock, therefore leaving the surrounding buildings undisturbed, which is one benefit among others provided by the use of this method rather than using a concrete slab (Fig.5):

Fig.5 Ground plan showing the steel platform with cross sections (Drawing by: M. Tutkovski)  
 Сл.5 Основа и пресеци на челичната платформа (Цртеж М. Тутковски)

The platform has three constituents: concrete bases, primary and secondary construction. The concrete bases carry the primary construction, built from steel profiles in  $\Pi$  shape, over which the secondary construction shaped as a steel grid holds the mosaic sections. Prior to assembling, all the steel components were covered in double layers of anti-corrosion varnish, to which another layer was added after the construction was finalized.

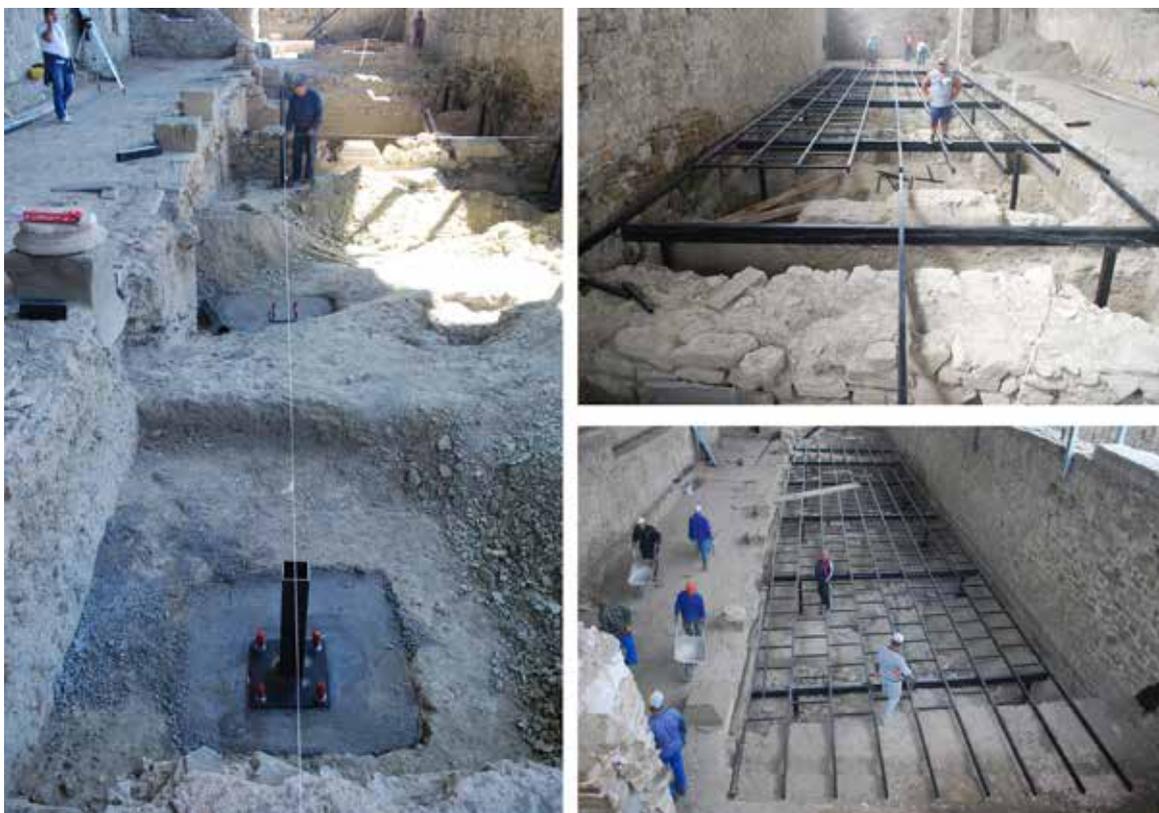
Fig.6 Constructing the steel platform (photo: M. Tutkovski)  
 Сл.6 Изградба на челичната платформа (Фотографија М. Тутковски)

The task of installing the platform began by digging and laying concrete foundations, which measure 100x100x100 cm<sup>17</sup>. Cast iron reinforcement bars were installed inside the concrete piers, having horizontal steel plates placed over them and secured with bolts (Fig.6). In this way, the entire construction above the concrete bases has the attribute of being detachable, thus remaining fully within the principles of reversibility. The vertical beams (10x10cm) are welded to the steel plate, bearing the horizontal beams (20x10cm) which in turn are the base of support for the secondary construction.

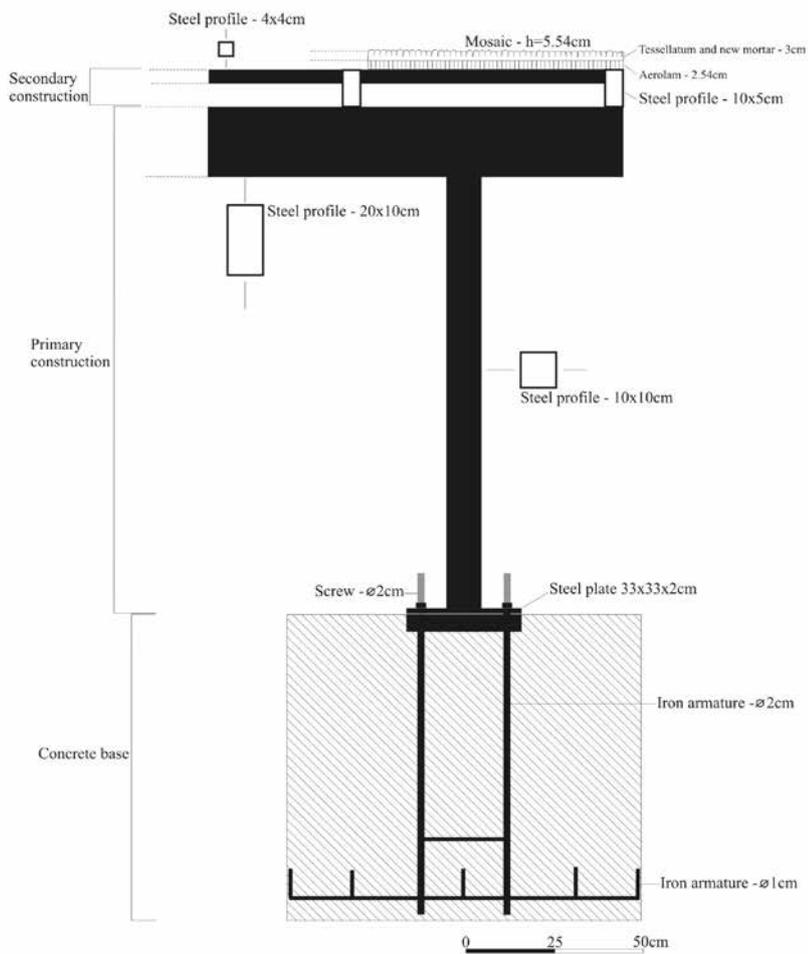
Fig.7 Cross section of the steel platform components with re-layed mosaic – detail (Drawing by: M. Tutkovski)  
 Сл.7 Пресек на компонентите од челичната платформа со поставен мозаик (Цртеж М. Тутковски)

The secondary construction is in the shape of a grid with rectangular sections measuring 69 x 69 cm. It is built up of 9 rows of steel profiles (10x5cm), placed in line with the axis of the basilica. All of them are welded to the bearing partition of the primary construction, and have smaller steel profiles (4x4cm) attached in between and creating the grid. There were additional smaller profiles welded as well (10x5cm)

to the southern and northern edges of the structure for the purpose of following the outer preserved contours of the mosaic (Fig.7).

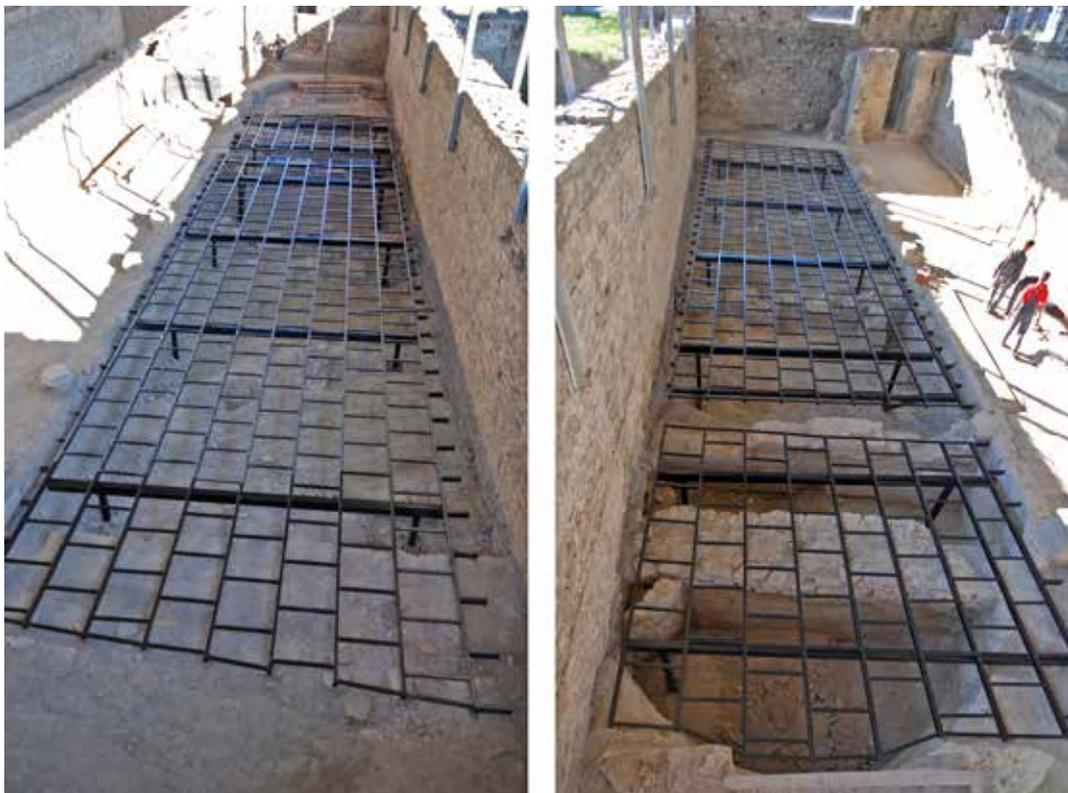
Fig.8 Completed steel platform (photo: M. Tutkovski)  
 Сл.8 Финален изглед на челичната платформа (Фотографија М. Тутковски)

The entire bearing structure was constructed in two parts (eastern and western), created identically and with the use of the same materials. The need for creating the bearing structure in two parts is due to adequate presentation of the three different phases of the mosaic, namely, the original leveling of the mosaics from the first and second phase shows a downward inclination of 30 cm from west to east, while the third phase mosaic descends 5 centimeters in the opposite direction. Therefore, dividing the entire supporting structure into two parts proved necessary, as to providing proper installation as well as presentation of all the mosaics in their original position (Fig.8).

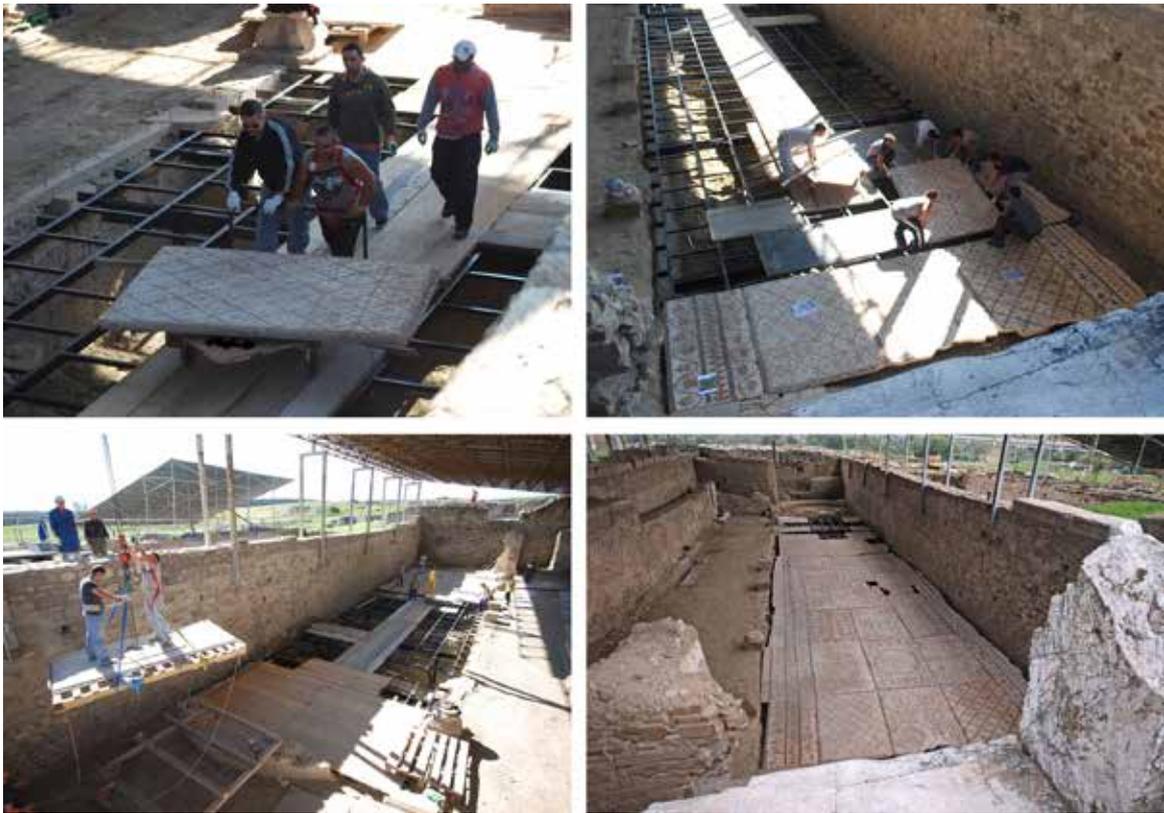
Fig.9 Re-laying the mosaic panels in situ (photo: M. Tutkovski, M. Filova)

The platform construction was finished in 12 days, after which steps were taken for re-laying the mosaic. The mosaic sections (70 in total) were placed over the secondary construction, followed by attaching and retouching the joints, as to blend them into achieving the authentic look (Fig.9). Retouch was made using the same mortar applied as mosaics backing, and the tesserae used originate from the mosaic itself<sup>18</sup>. The parts where opus sectile impressions were preserved in mortar were covered with ribbed plastic-coated

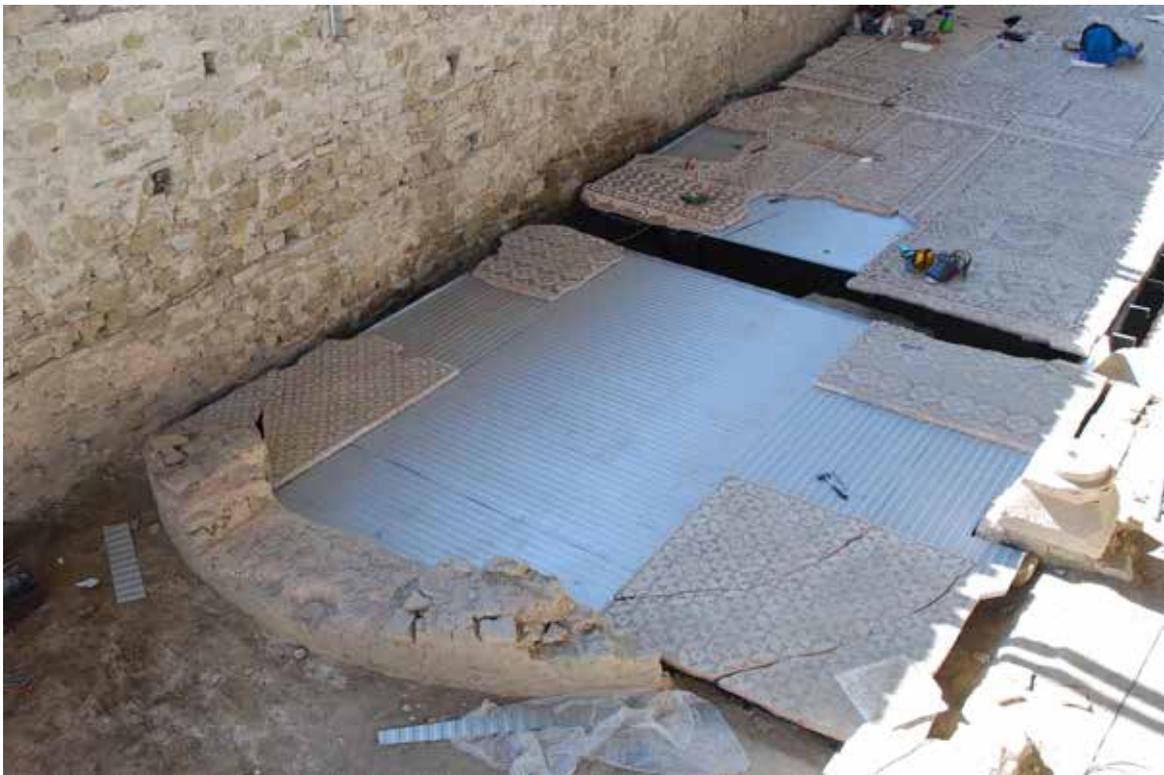
Fig.10 Covering the areas with ribbed aluminum sheets (photo: M. Tutkovski)

metal sheets, which were bolted to the steel construction (Fig.10) and covered with gravel with similar coloration to the original mortar imprints. The same gravel was used for filling the smaller lacunae in the surface of the mosaic, as well as the area between the two apses from the basilica. This concluded the planned restoration activities on the mosaic from the Old Episcopal Basilica (Fig.11-12).

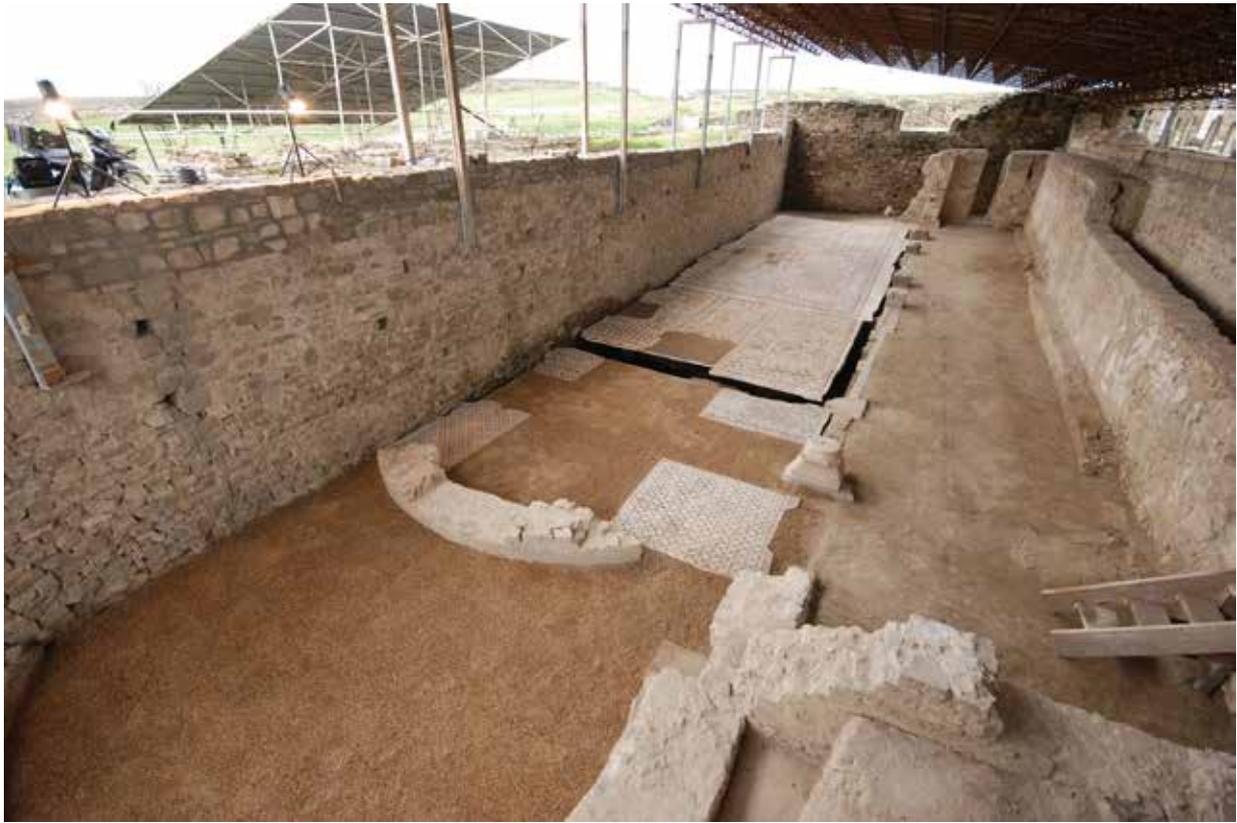
Fig.11 Final view of the Old episcopal basilica with re-layed mosaics (photo: M. Tutkovski)

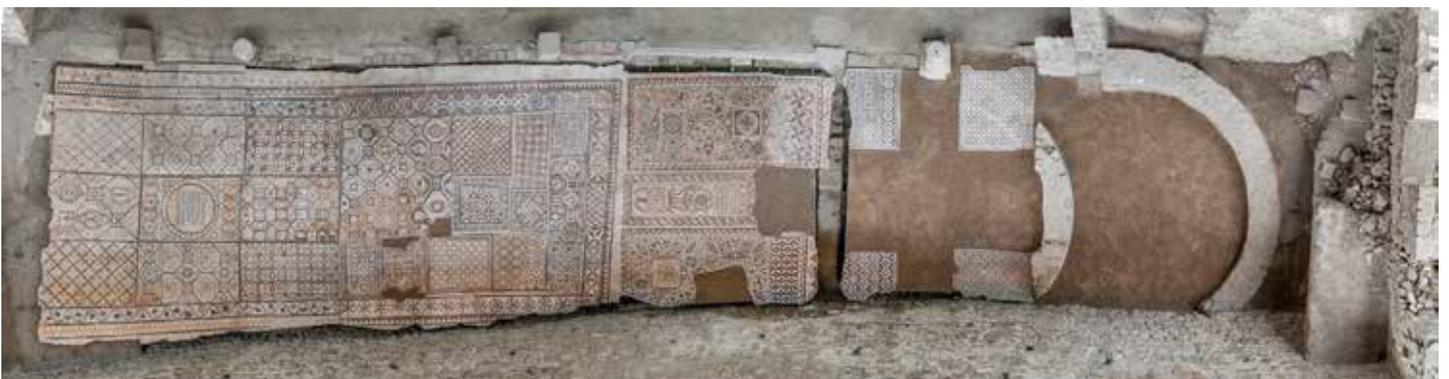
Fig.12 Orthophoto of the mosaic in the central aisle (photo: M. Tutkovski)
