## INDOOR AND OUTDOOR MEASUREMENT OF THE “T” AND “RH” AND CLIMATE IMPACT ON THE CULTURAL HERITAGE IN THE CHURCH OF ST. SPAS IN SKOPJE

**Key words:** church St. Spas in Skopje, T and RH measurements, microclimate conditions, preventive protection, cultural heritage.

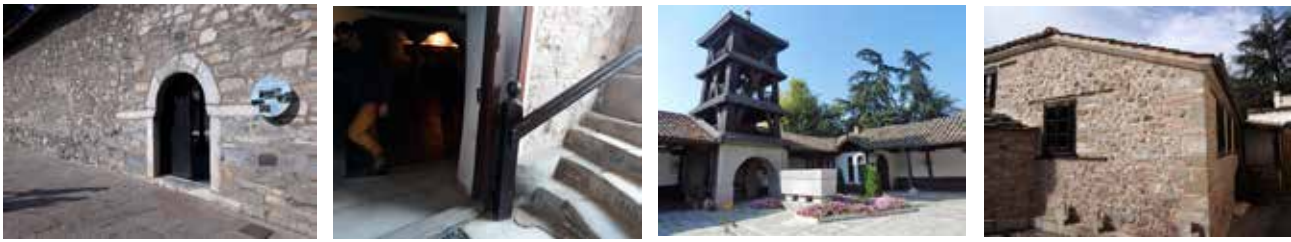
Fig.1 – Different views of the church: a) - entrance from the south side of the fortitude wall, b) - the entrance to the excavated church; c) - the bell tower in the yard, d) - the north side of the church with the location of the fountain next to the conservation laboratory

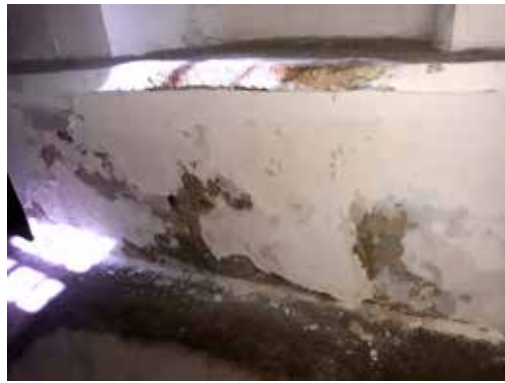
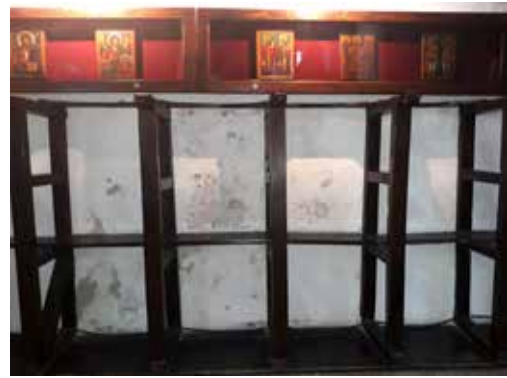
Fig.2 – The state of the altar apse during the 2011 year with increased moisture

is reflected by landslides on the east wall or with the appearance of capillary moisture most at the foot of the walls. These factors influence the microclimatic changes in the church, nevertheless disturbing the stable microclimate, favorable for the preservation of this type of material cultural heritage. Humidity and temperature measurements were carried out during a one-year cycle in 2011 to determine the parameters when increased capillary moisture occurred mainly in the northeastern enclosed parts of the church walls (Fig.2-a,b) during the winter of 2010. Since the church is surrounded by fortification walls, measurements were made simultaneously outside the walls, inside the courtyard, as well as inside the church whose bottom of the base floor is below the level of the courtyard.

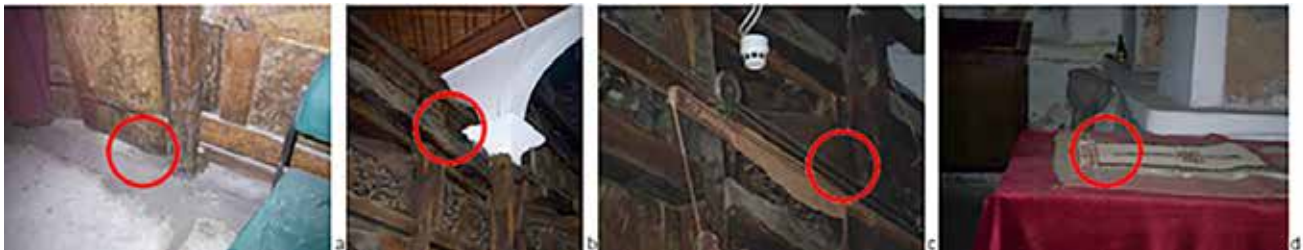
During the liturgy 11.05.2011 (from 15.30 pm) until 12.05.2011 (11.20 am) the logger was placed in the altar of the Sacramental table at a height of 1m. Inside the apse there was a stagnant air and a certain amount of moisture, due to the height of the iconostasis but also because of the closing all the openings

Fig.3 - Three (3) measuring points along the middle of the iconostasis: a)- at the foot of (-1.57m), north wing the Royal Doors; b)- at a height above the Royal Doors, c) - On the second upper beam of the south wing of the iconostasis, at the height of The Great Cross and 1 measuring point; d)- in the altar apse at the height of the Sacrificial Table

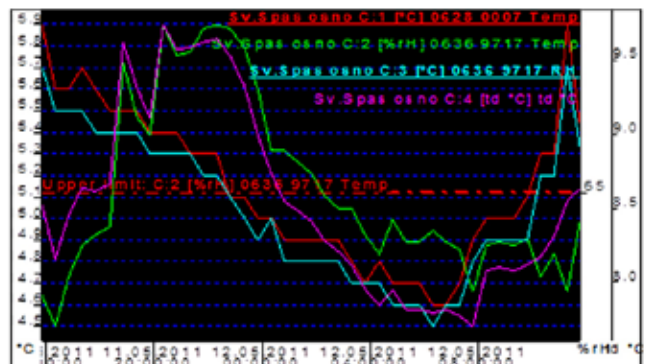
with a heavy velvet drapery (curtain) placed above the Royal doors. The measurements showed that the outside temperature and moisture were: 17°C-20%-south side, 18°C-48%-west side and 17°C-54% north-west side outside of the walls, while during these measurements the climate in the church yard was 42-46% moisture and 18.8°C-19.1°C temperature, before it was interfered with some fluctuations increased in relation to the day of the liturgy and the crowd, which during the following days participated as a reflex for those disturbances (Fig. 4).

Fig.4–The measurement from the 4 measuring points in the interior ambient of the church on the solemn liturgy (11.05 till 12.05.2011)

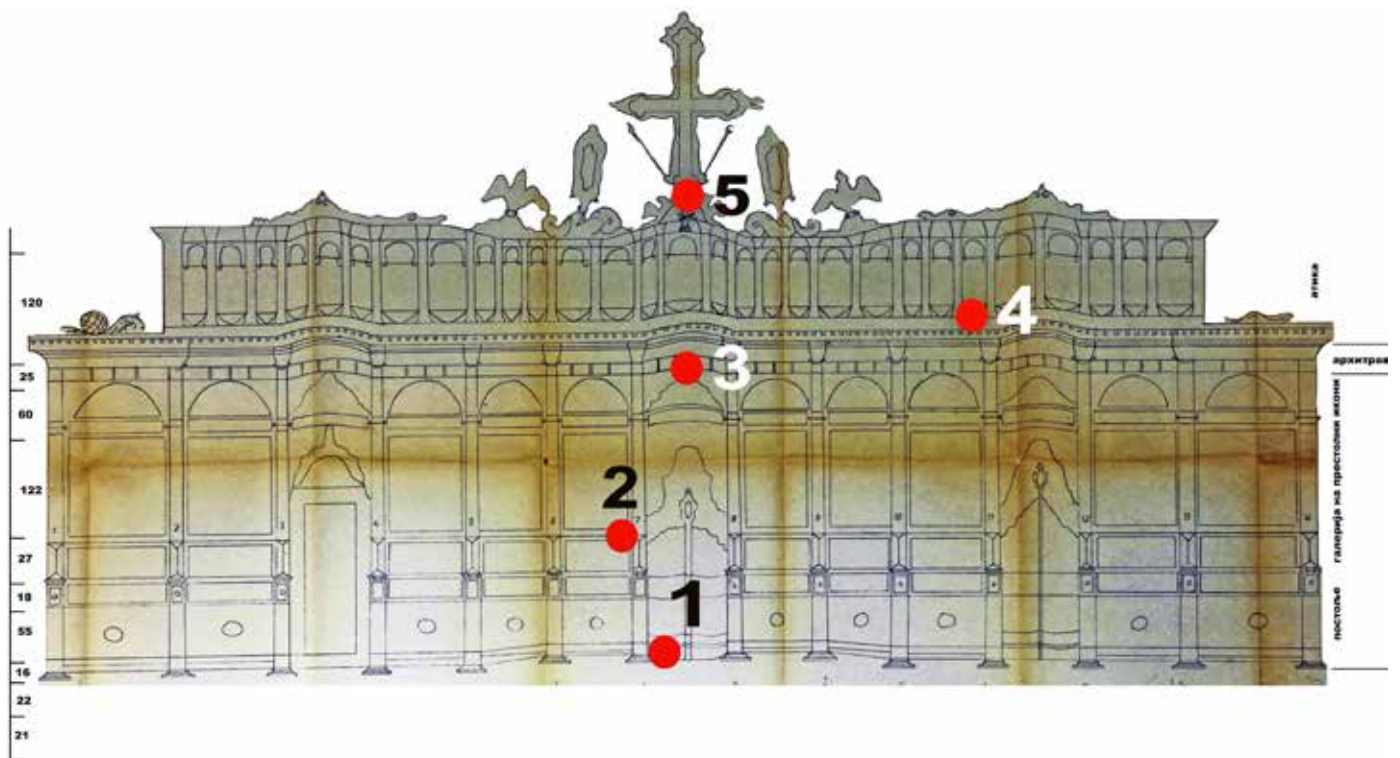
- Along with the church's internal and external measurements, there were 5 reference points placed at different elevation of the iconostasis construction raising from the parapet as the first measuring point, or the bottom of the iconostasis which starts from -97 cm, in the relation to the church floor-1.97 m below ground level, up to the throne icons, and the upper zone of the wood carvings, until the highest one on the Great Cross (Fig.7).

Fig.7 - The measurement on the iconostasis: 1. Royal doors - the foundation; 2. Throne icons - down base; 3. Above the Royal doors; 4. Attica - upper beam -feasts icons

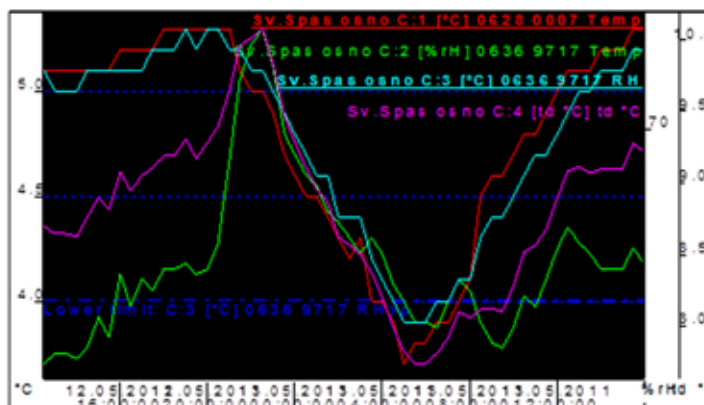
Fig.8 – Graphicon of the Internal measurements during 11.05.2011-12.05.2011 positioning in a direction of the graphical rose

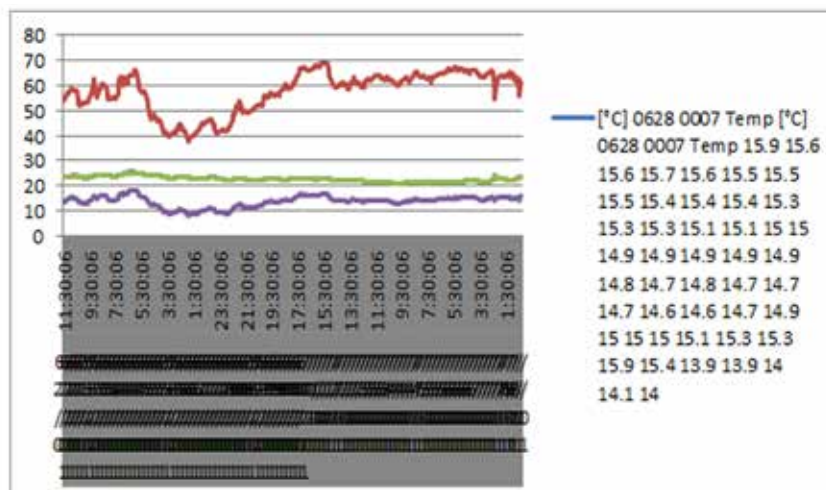
Fig. 9 - On 25-28 June 2011 RH humidity decreases significantly following the outdoor temperature, in contrary and regardless of the indoor temperature

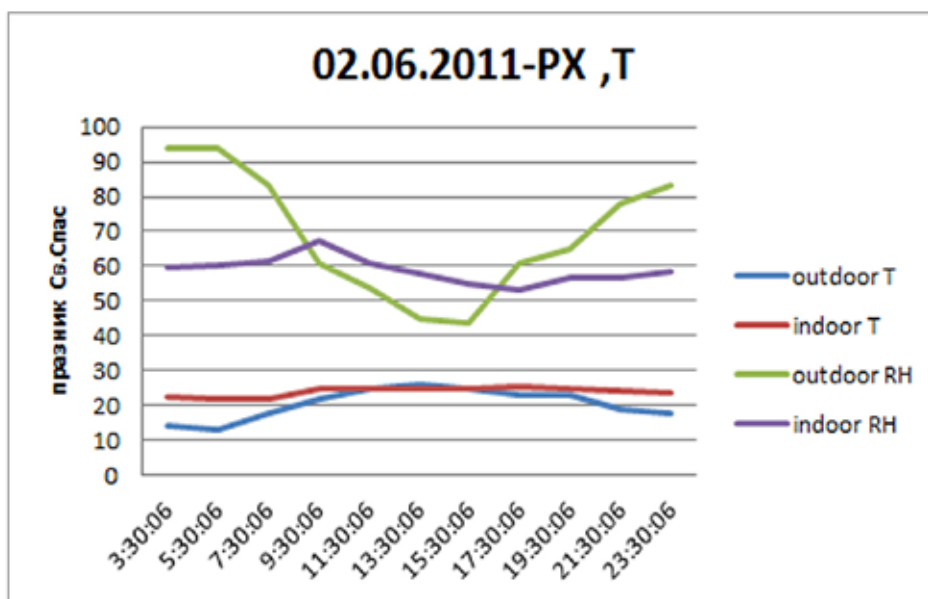
Fig.10 – The oscillations of the RH and T (outdoor and indoor) per one day and night

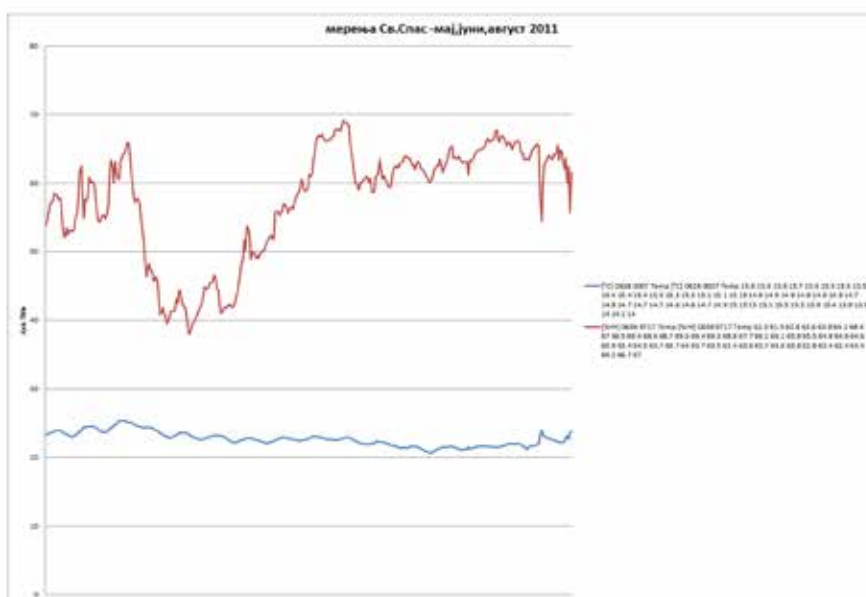
Fig.11 – Indoor measurements of the RH and T in the church during the summer period in 2011 and the fluctuation during the month of June 2011

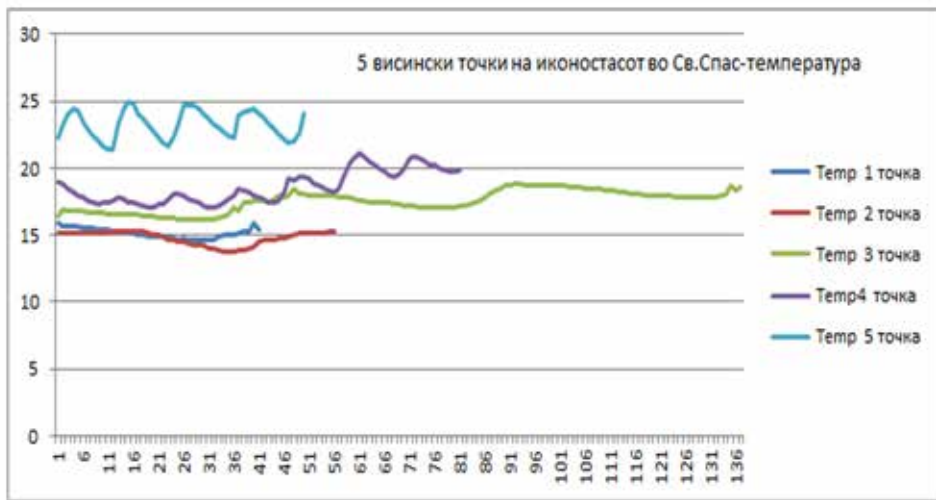
*Measurements on different high levels on the iconostasis underlining the differences of T and RH picks measured with five(5) data mini loggers set on the central altitude position: 1)- measuring point is at -97 or height on the parapet slab, the base of iconostasis, 2)-height of the throne icons, 3)- Rebellion - above the Royal doors; 4) - Attica - upper beam, the height of the feasts icons; 5) - the higher point the Cross. The loggers were set at approximately on every 1.20 m in height.*

Fig. 12 - Five (5) different points on the iconostasis in the church measuring the temperature

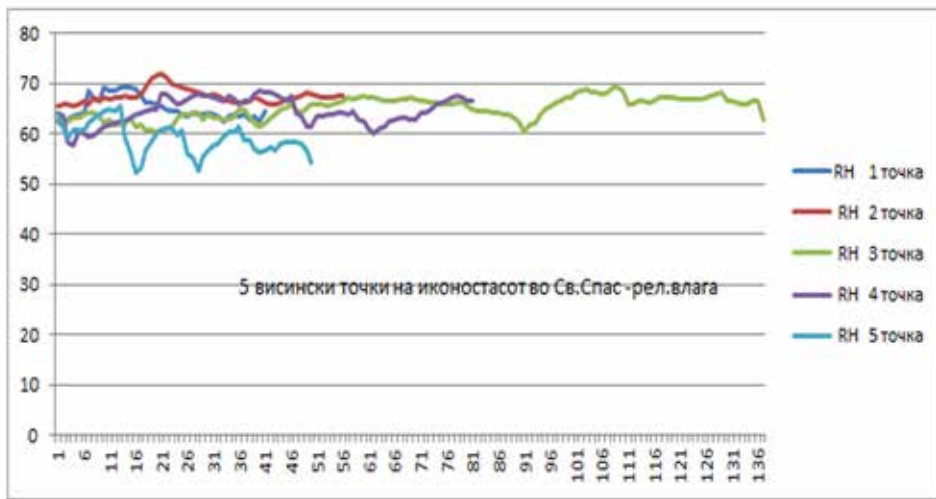
Fig. 13 - 5 different points on the iconostasis in the church measuring the Relative humidity

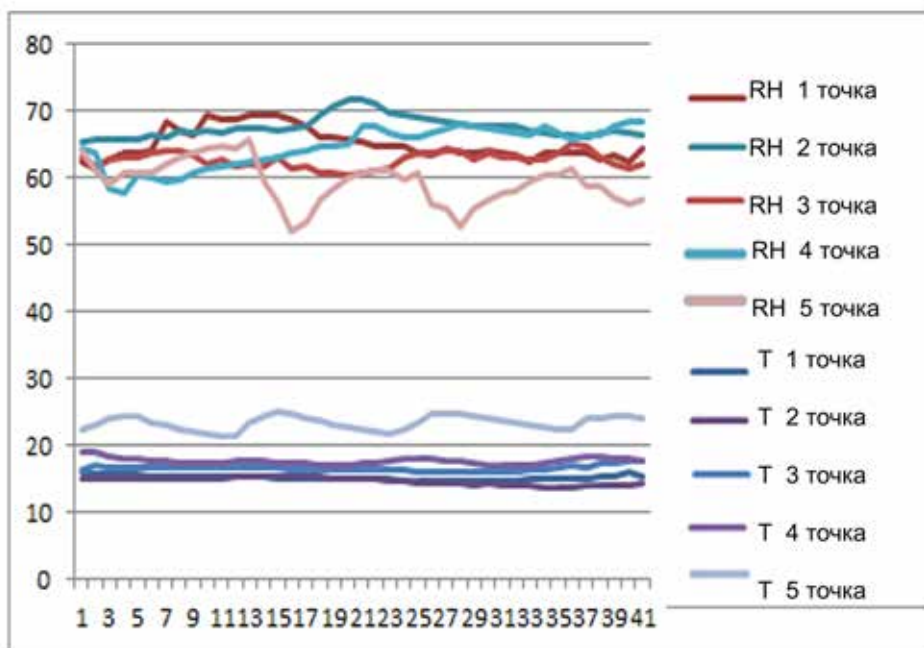
Fig. 14 - 5 different points RH and T on the iconostasis

- The measurements of the iconostasis showed different temperature and RH differences in relation to the height point;

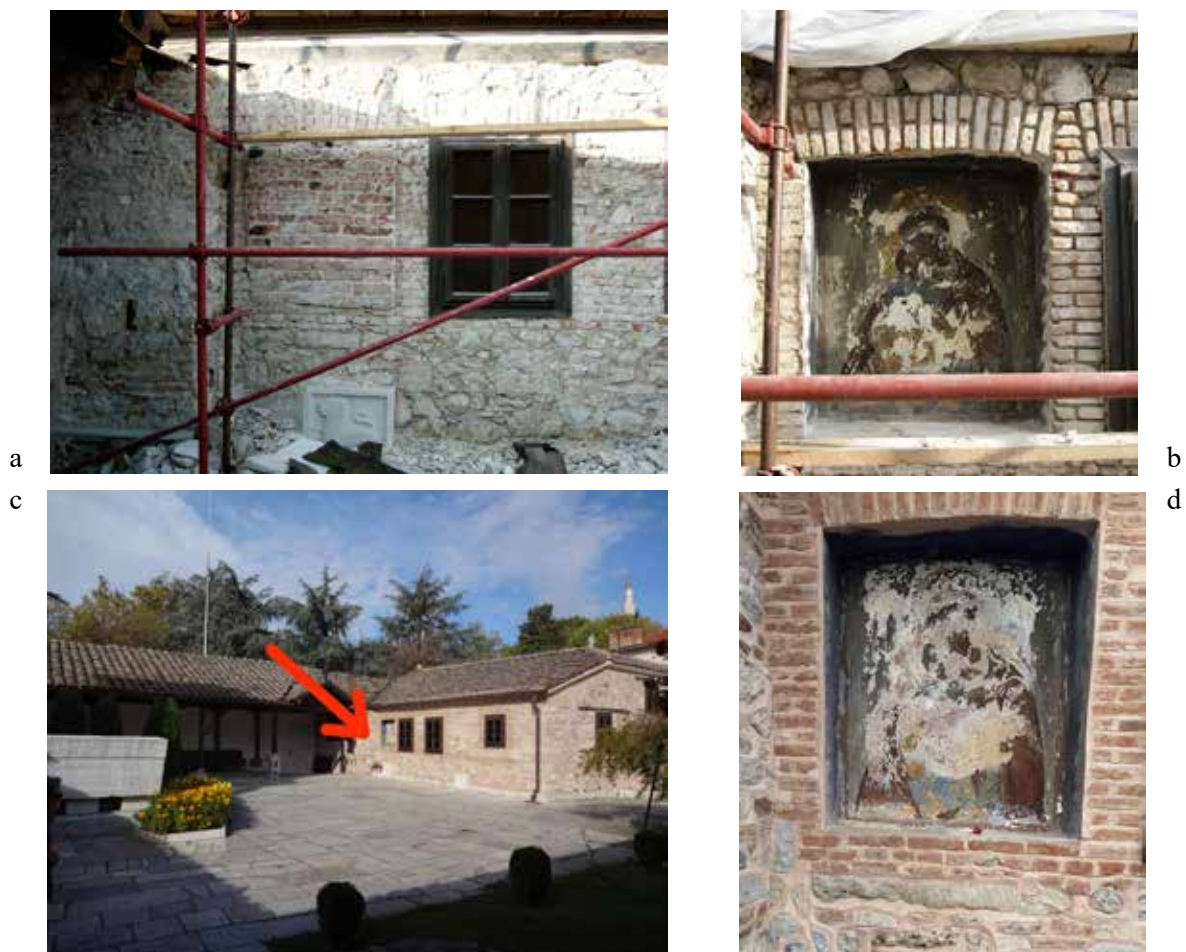
Fig.15 - a) - Conservation architectural processes on the south wall in 2004 and the location of the fresco before the discovering, b) - the fresco Virgin Mary with the Child from 16-17 century; c) - Untill nowadays the fresco is still not sheltered from the sun; d) - Today's outlook of the fresco in 2021 year.

- During the conservation work in 2004-5 a fresco of the Virgin Mary with Child on the outer southern wall was discovered, but until now is not yet protected from the sun (Fig.15);
